RE: Site Inspection, GoldTerra, Blue Castle Mine, S/015/077, Emery County, Utah

Date of Inspection: March 28, 2003
Time of Inspection: about 5:10 to 5:20 p.m.
Conditions: Mostly clear, 40's
Participants: Paul Baker (DOGM)

S/015/077, Blue Castle Mine, GoldTerra

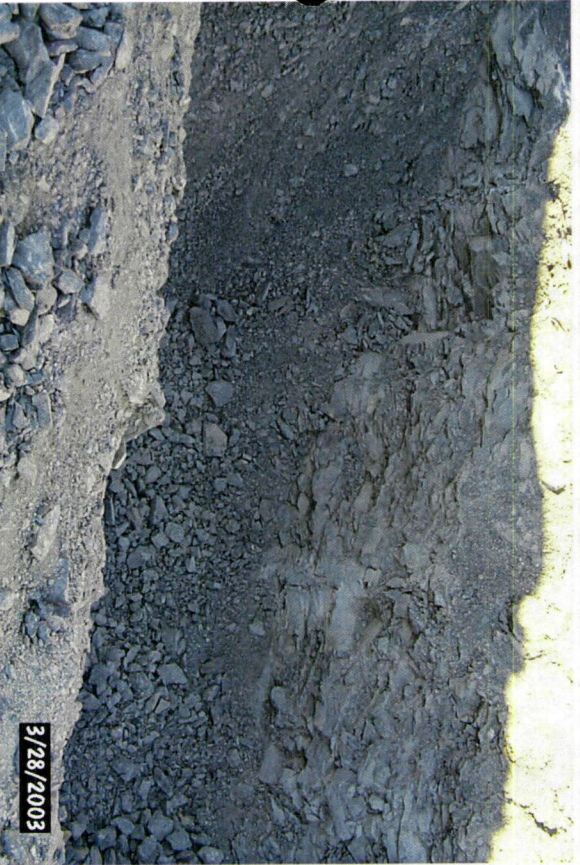
The site consists of an excavation I estimated at about 25 feet deep. Photo 1 was taken looking down into the hole. Photo 2 shows some of the material dug from the pit.

The pit is deep enough with sides that are steep enough that there is some danger to the public. Although there is a warning sign, the pit should be at least partially filled in or sloped so the sides are not quite so steep if possible.

Photo 1. Looking from the top of the excavated material into the pit.
